Field Report, August 8, 2008

Bill Macintire, Kentucky Heritage Council

This is a report of the findings of an examination of a house built of unfired earthen blocks, plastered on the interior and until recently, covered on the exterior with siding. The house is located in Greensburg, in Green County, Kentucky. Until recently, its unusual construction technique was unknown to anyone with the possible exception of some past residents and electrical contactors. The church next door recently purchased the property and elected to tear down the house. The details of the house's construction technique persuaded them to stop the demolition process to get an opinion on what it was that was being torn down.

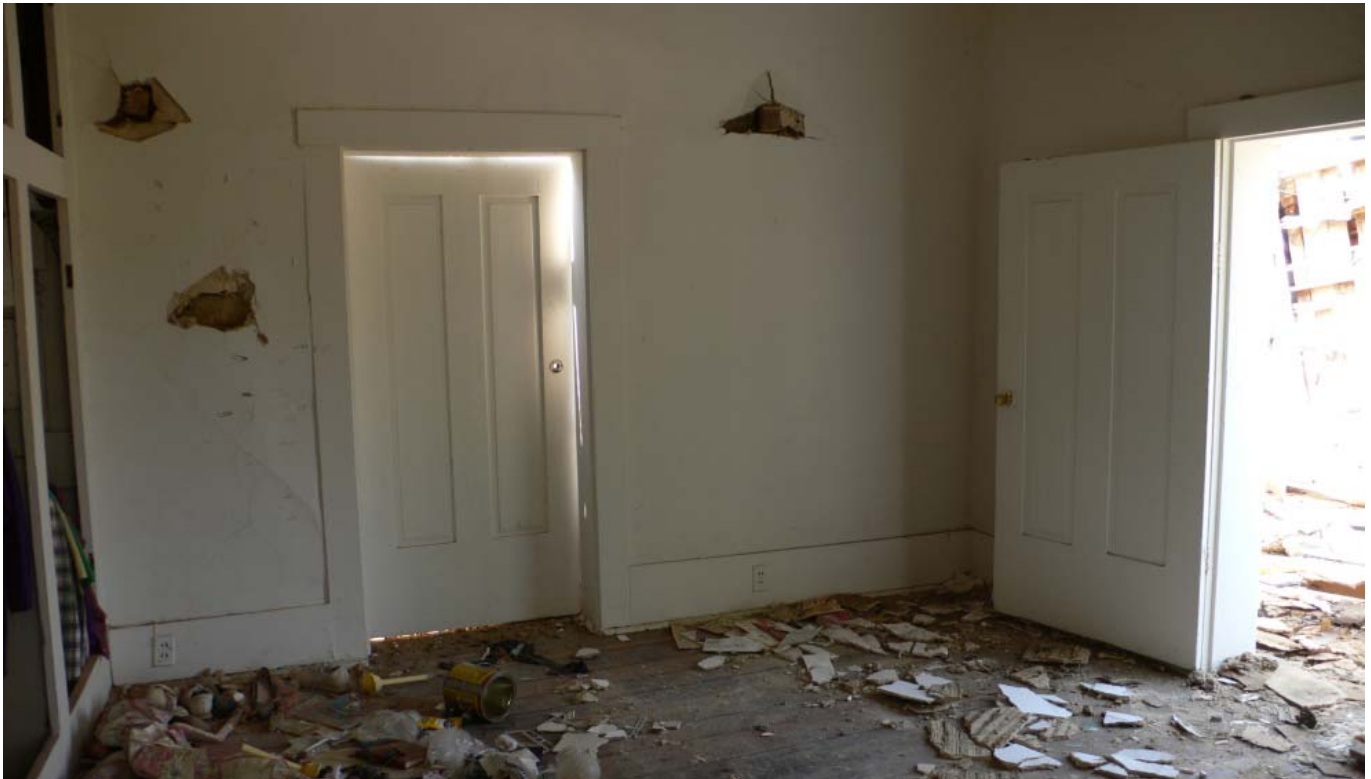
2. Interior of the bedroom. The outward swinging door is on the left.

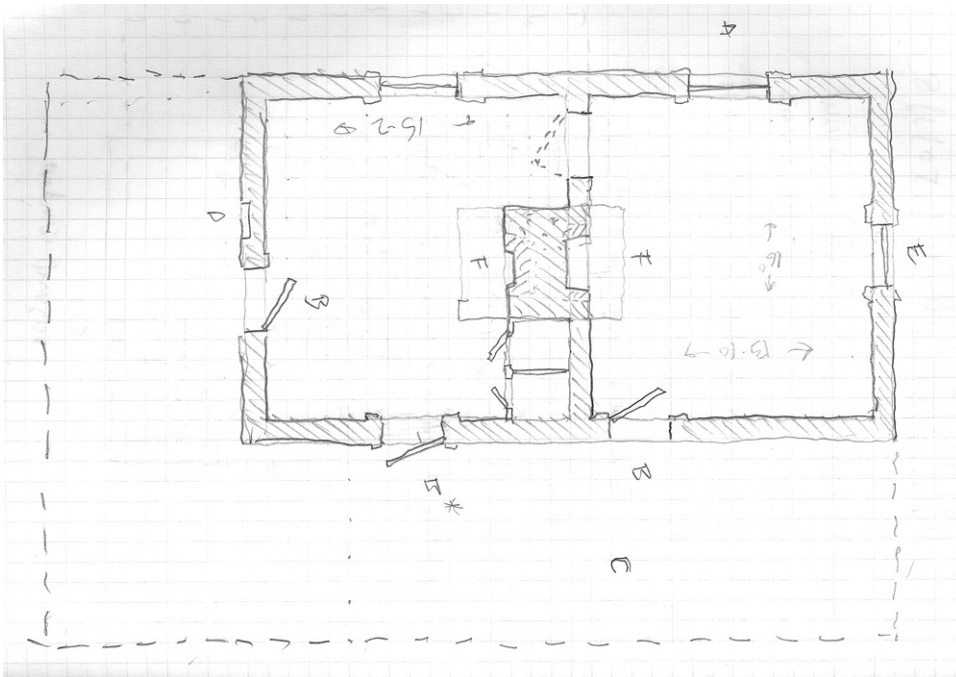
3 Floor plan of the house. The room on the left was a bedroom, the room on the right, the parlor. The extent of the additions is indicated by the dotted line. One square on the graph paper is roughly one square foot.

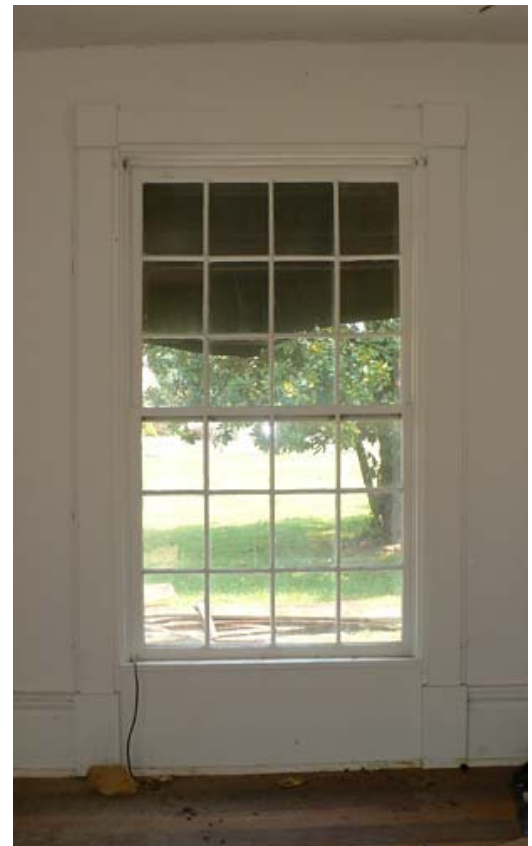
4. Window in the parlor.

The windows are one of the remarkable features of the house – large, double hung sash windows with sills close to the floor (figure 4). There are 16/16 lights on the front windows and 12/12 on the single side window. They may have been salvaged from another house or production overrun from another project, as they would more normally be used for larger rooms with higher ceilings. The effect though, is quite wonderful – the small rooms are very well lit and have a sense of large scale they would not otherwise enjoy.

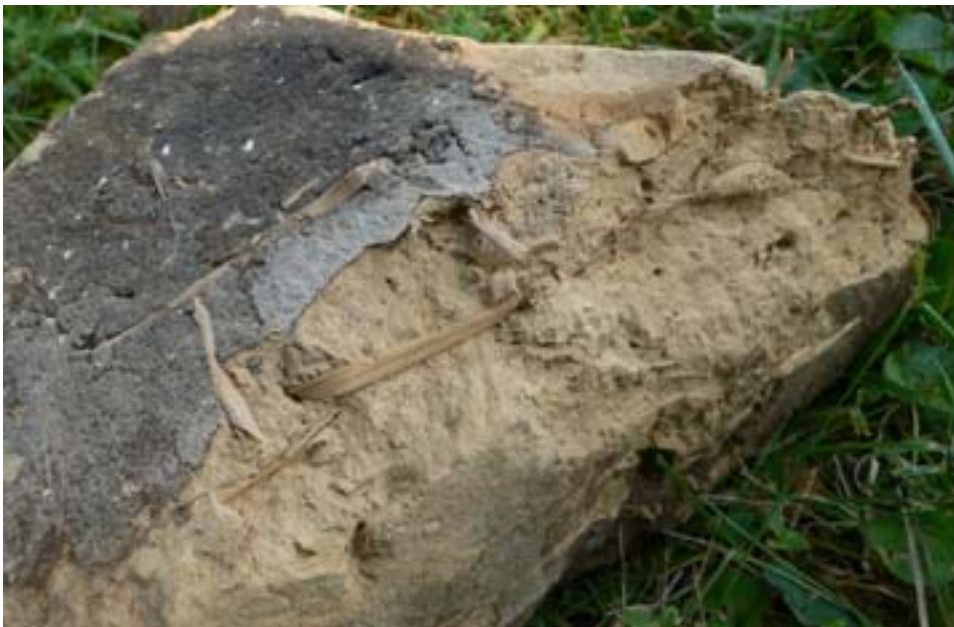
5. Detail of one of the Mud Bricks. Note the presence of straw, which clearly shows the brick was not fired.

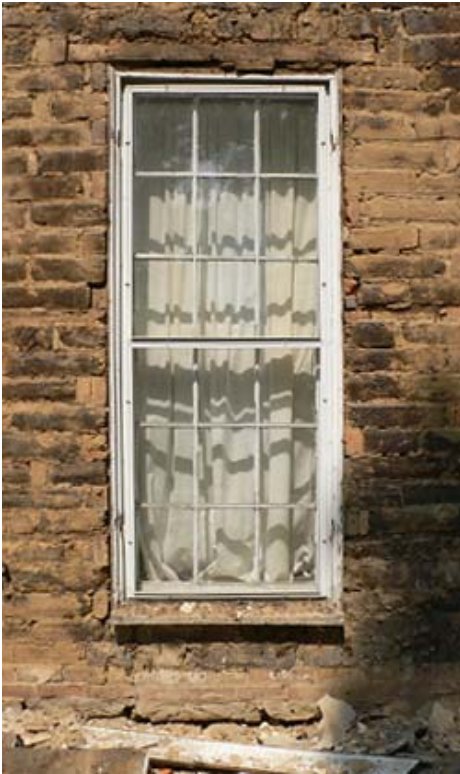
6. Exterior of side window.

The foundation (visible in figure 6, below) has a bottom layer of roughly cut stone extending several inches above grade. On top of this foundation are two courses of fired brick, and then the unfired brick rests above that. After about 8-9 courses of mud brick, there is a thin layer of wood. These are repeated regularly up the wall. The wood layers were probably inserted to facilitate the leveling and plumbness of the walls as well as the attachment of interior trim. They later served as nailers for the attachment of exterior trim. Masonry construction is used for all the exterior walling and a part of the chimney stack and interior wall. The mortar appears to be almost like mud, but may be course lime putty. There are remnants of a smooth plaster finish on the exterior, which appears to have sloughed off: then the exterior was covered with circular sawn, cut-nailed board and batten siding. Other exterior trim included
